File Number: **450- 062008 – Older Home # 4**

The inspected property consisted of a wood framed two story structure that was occupied at the time of the inspection. The approximate temperature at the time of the inspection was 70 to 75 degrees Fahrenheit, and the weather was clear. The utilities were on at the time of the inspection. The buyer and buyer's agent were present during the inspection.

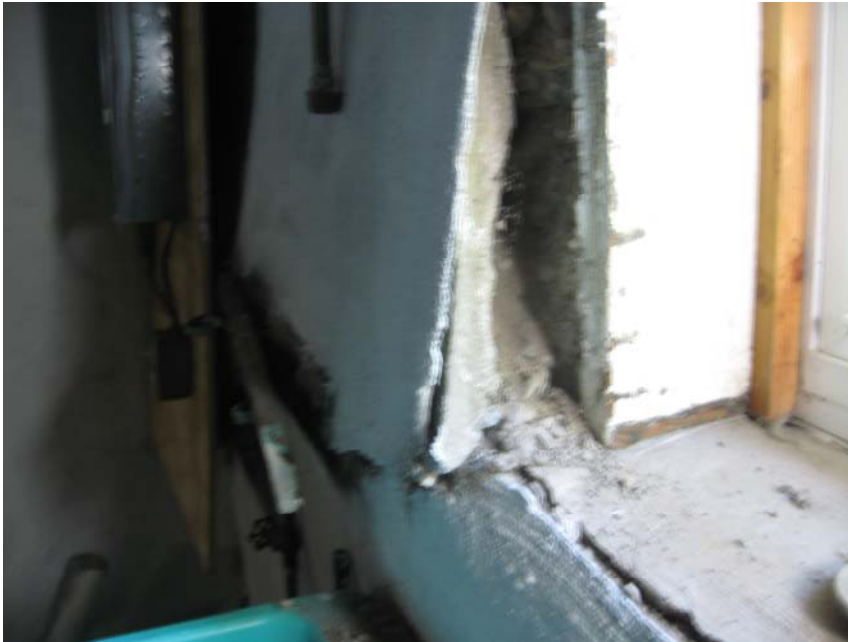
The foundation is constructed of poured concrete. The exterior of the foundation has been covered with cement board and is not visible. The interior visible areas of the concrete foundation, especially the right and left sides, are soft and crumbling. The front half of the right side wall has a block wall built along the interior to contain the crumbling concrete. The remainder of the right wall have cement board nailed to the wall in an attempt to contain the crumbling concrete. The cement board is pulled away from the wall and is fractured in spots.

- 1. We recommend that a qualified masonry contractor inspect the foundation to determine the scope and cost of necessary repairs.***
