***PURPOSE OF A HOME INSPECTION:***

File Number: **450- 102007- 0000**  
Address of Inspection: **Actual Report – Older Home1**  
**This report is exclusively for the use of:**

The inspected property consisted of a wood framed two story structure that was occupied at the time of the inspection. The approximate temperature at the time of the inspection was 50 to 55 degrees Fahrenheit, and the weather was clear. The utilities were on at the time of the inspection. The buyer and buyer's agent were present during the inspection.

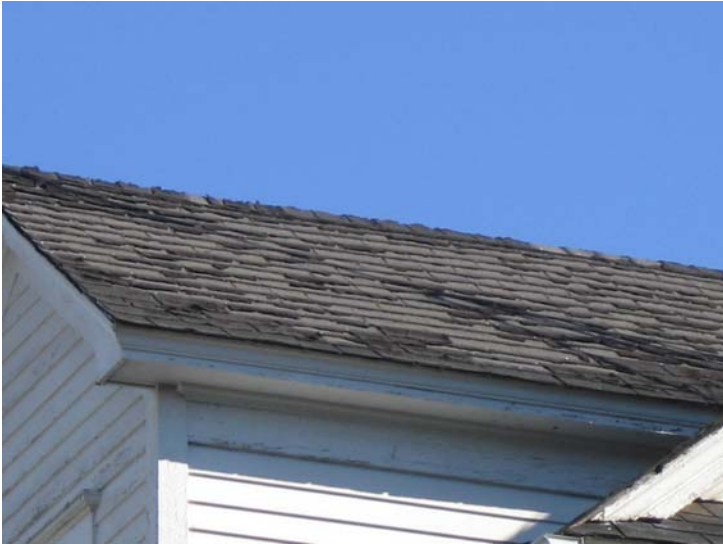
The roof was a gable style. The roof is covered with asphalt three tab shingles. Observation of the roof surfaces and flashing was performed from the ground with the aid of binoculars. There appeared to be two layers of shingles on the roof at the time of the inspection. There was moderate surface wear and moderate curling observed on the roof shingles at the time of the inspection. These conditions indicate the roof covering was in the last quarter of its useful life. The reported condition of the roof covering is based on a visible observation of the visible roof covering and does not in any way relate to the age of the roof covering. Many factors such as the quality and type of the covering, number of layers of roof covering, the pitch of the roof and how well the attic or space under the roof is ventilated enter into the actual life span of the roof covering.

- 1. The rood covering on the front of the dormer and the front and rear valley covering at the dormer needs to be replaced.***

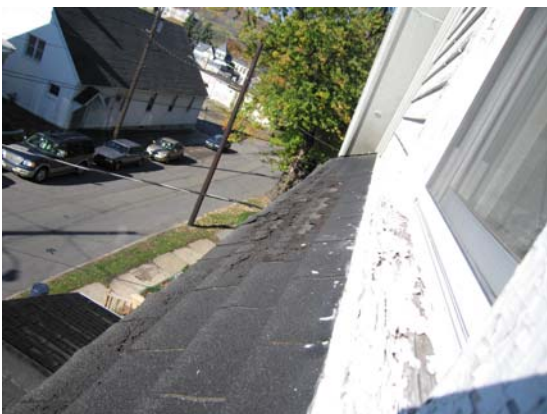
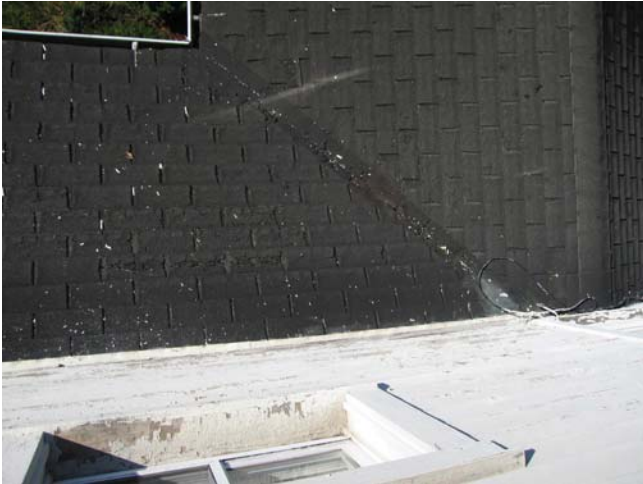
**FRONT PORCH & RETURN AT FRONT GABLE**

The roof is covered with asphalt three tab shingles. Observation of the roof surfaces and flashing was performed from above the roof. There appeared to be two layers of shingles on the roof at the time of the inspection. There was heavy surface wear and heavy curling observed on the roof shingles at the time of the inspection. These conditions indicate the roof covering was at the end of its useful life.

- 1. The porch and return roof covering needs to be replaced.***

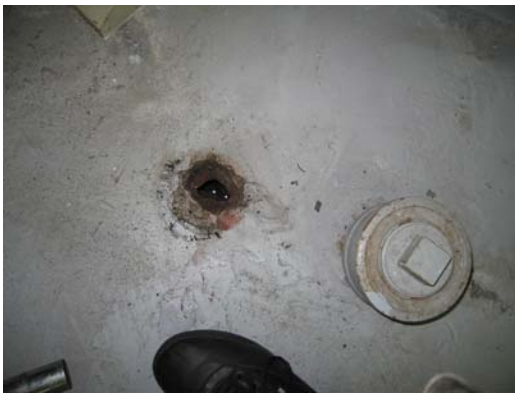
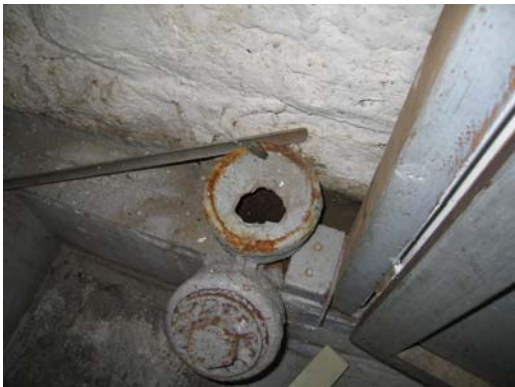
The main water supply line to the home is copper pipe. The visible water supply lines throughout the home were copper pipe. There are two leaks in the cold water domestic water line above the water heater at the front of the basement. The water was supplied by a public utility. The visible waste lines consisted of ABS plastic and cast iron pipe. The home was connected to a public sewer system. Water flow throughout the home was normal. There were no major visual defects observed in the visible portions of the plumbing system.

- 1. Repair the domestic water line leaks above the front water heater.***
- 2. Cap the open waste lines at the front right of the basement.***

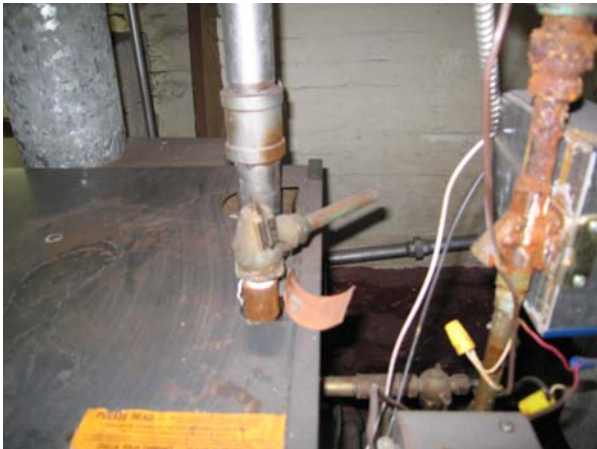
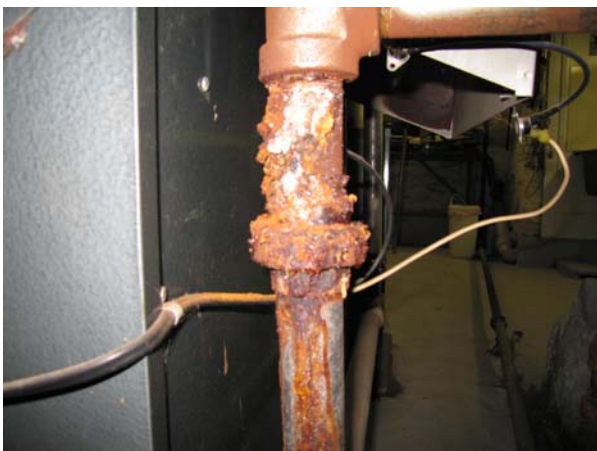
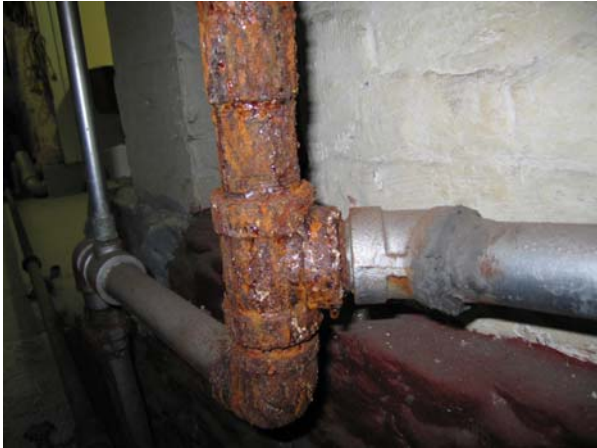
The boiler was tested and found to be functional and in good operating condition at the time of the inspection, however the steam return, at the boiler is corroded and leaking and must be replaced.

- 1. Replace the rusted and leaking steam return lines at the boiler.***
- 2. Extend the piping from the temperature and pressure relief valve to within six inches of the floor. The piping must be three quarter inch inside diameter.***
- 3. Install screws in the joints of the flue piping.***
- 4. Carefully wrap the asbestos like material with heavy gage aluminum foil and seal with duct tape or have it professionally removed.***
- 5. Replace the corroded piping at the water auto feed valve.***

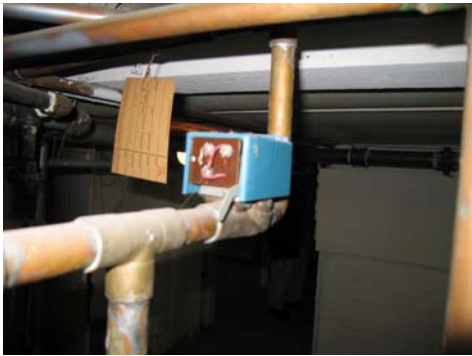
The boiler was tested and found to be functional and in good operating condition at the time of the inspection, however the zone valves for the basement and first floor thermostats are disconnected and were not functional at the time of the inspection.

- 1. Have the zone valves repaired or replaced and the system put back into proper operating condition by a qualified HVAC technician.***
- 2. Extend the piping from the temperature and pressure relief valve to within six inches of the floor. The inside diameter of the pipe must be three quarter inch.***

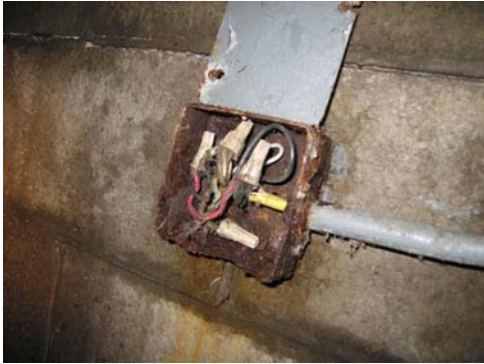
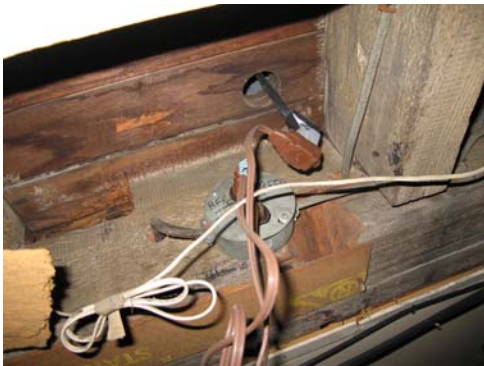
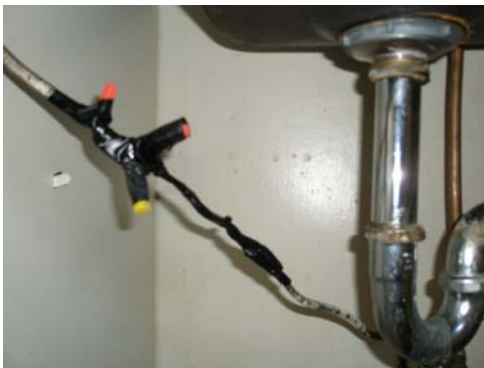
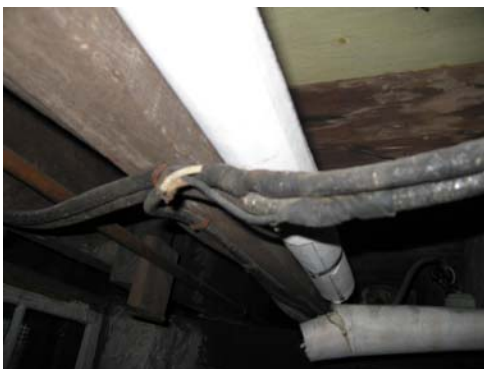
The branch circuits within the panel were copper. These branch circuits and the breakers to which they were attached appeared to be appropriately matched with the exception of the 30 AMP single pole breaker in the right panel which is attached to twelve gage wire which has a maximum amperage capacity of 20 AMPS. This breaker must be replaced with a 20 AMP breaker.

There is an open junction box which is in a wet location in the basement entrance way. This junction box needs to be removed and replace with a water tight junction box.

This type of Federal Pacific panel, that uses “stab lock breakers” is obsolete. Breakers are no longer available for these panels. These panels have had reported problems in the past where breakers have failed to trip therefore not providing the expected protection.

- 8. GFCI receptacles or circuit breakers are recommended for the kitchen, garage, basement, bathrooms and outside circuits.*
- 9. There was one 15 AMP circuit breaker in the left panel which has been double tapped. In order to ensure that the designed level of service is provided to all circuits, it is recommended that each circuit be provided with a separate breaker.*

- 10. Replace the junction box in the basement entrance way with a water tight box.*
