File Number: **450- 062007- 0000**

Address of Inspection: **Actual Report – Older Home2**

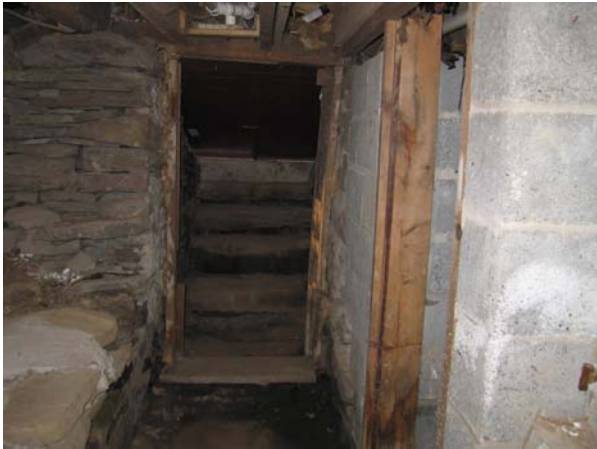
The basement windows are constructed of vinyl and are hopper style with insulated glass pane glass and in new condition. The door to the exterior is not installed. The outer flap door is a steel door and is in new condition.

- 1. Install a door to the exterior.***
- 2. Install a hand rail on the basement steps.***

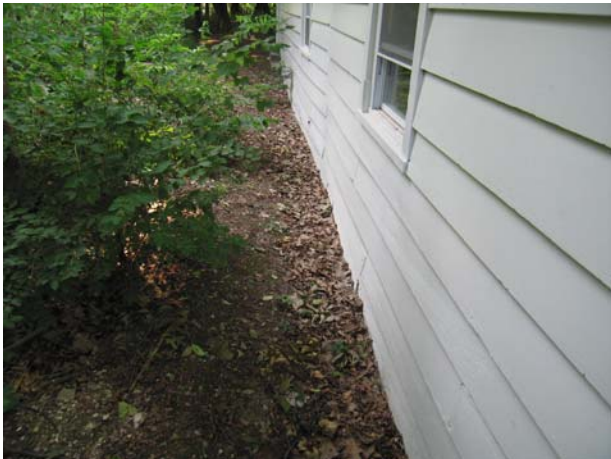
The wall structure is wood framed. The garage walls are unfinished. The exterior of the garage is sided with wood with wood soffit and fascia. There is ground to wood contact on

three sides of the garage.

- 1. Landscape around the garage to achieve a negative pitch away from the garage and at least six inches of clearance between the ground and wood siding.***

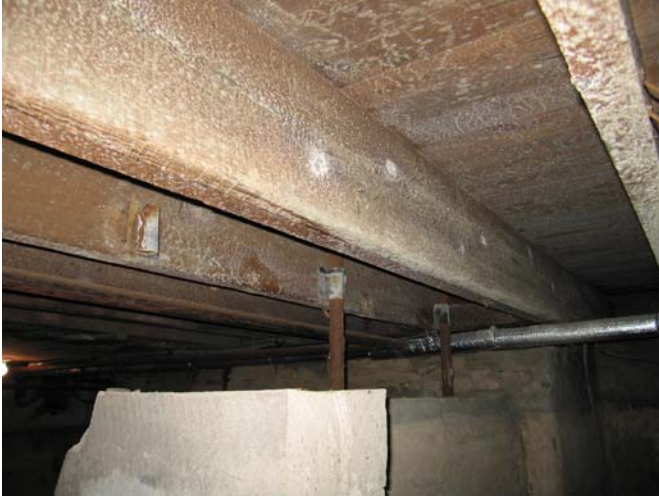
There is visible mold growth in the basement on the floor joists of the inspected home. Mold can be a health hazard depending on the type of mold and an individuals susceptibility to mold spores. If you are concerned about mold we recommend that the affected areas of the dwelling be tested to determine the type(s) of mold present.
